Manhole Inspection Summary

Manhole # S33II1003MH

Insp Date: **1/3/07 11:32 AM**

Location Address: **2 HIGHFIELD RD**

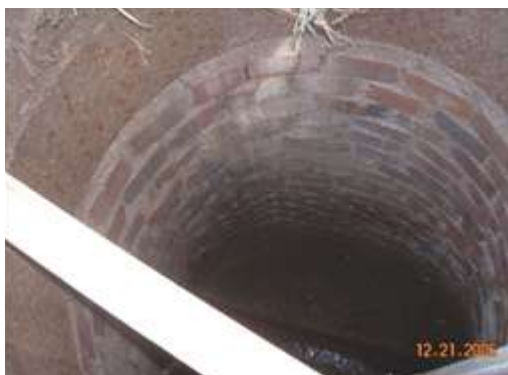
Defect

Condition: ☐ Sound ☐ Cracked ☐ Root Intrusion ☐ Loose Brick ☒ **Deteriorated**

Infiltration: ☐ None ☒ **Joint** ☐ Cracks ☐ Mortar ☐ Roots ☒ **Wall**

Infiltration: ☐ None ☐ Joint ☐ Cracks ☒ **Mortar** ☐ Roots ☒ **Wall**

Adjustment deterioration and infiltration.
Barrel infiltration.

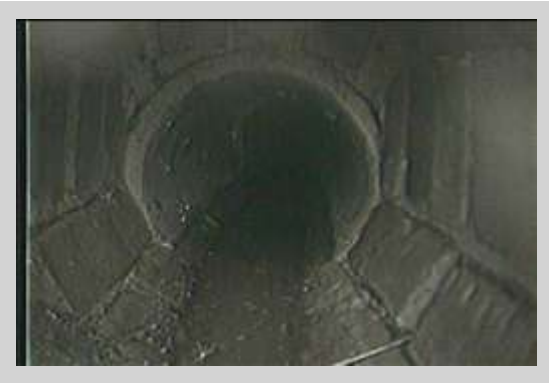
8 in. Circular Gravity Sewer Pipe Out @ 12 O'Clock

Deposits: ☐ None ☒ **Mud** ☐ Sludge ☒ **Debris** ☐ Grease

Infiltration: **Evidence** Pipe Seal Cond: **Cracked**

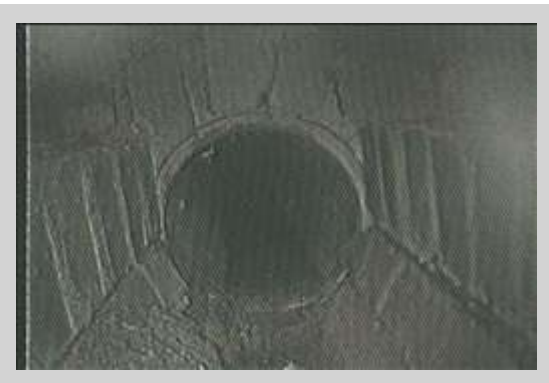
8 in. Circular Gravity Sewer Pipe In @ 6 O'Clock

Condition: ☐ Sound ☐ Cracked ☐ Root Intrusion ☒ **Deteriorated** ☐ Leaks ☐ Debris

Channel deterioration.

Infiltration: **Evidence** Pipe Seal Cond: **Cracked**
